Operation UPSHOT-KNOTHOLE

EFFECTS OF AN ATOMIC EXPLOSION ON UNDERGROUND AND
BASEMENT TYPES OF HOME SHELTERS

Report to the Test Director

Federal Civil Defense Administration
Washington, D. C.
October 1953

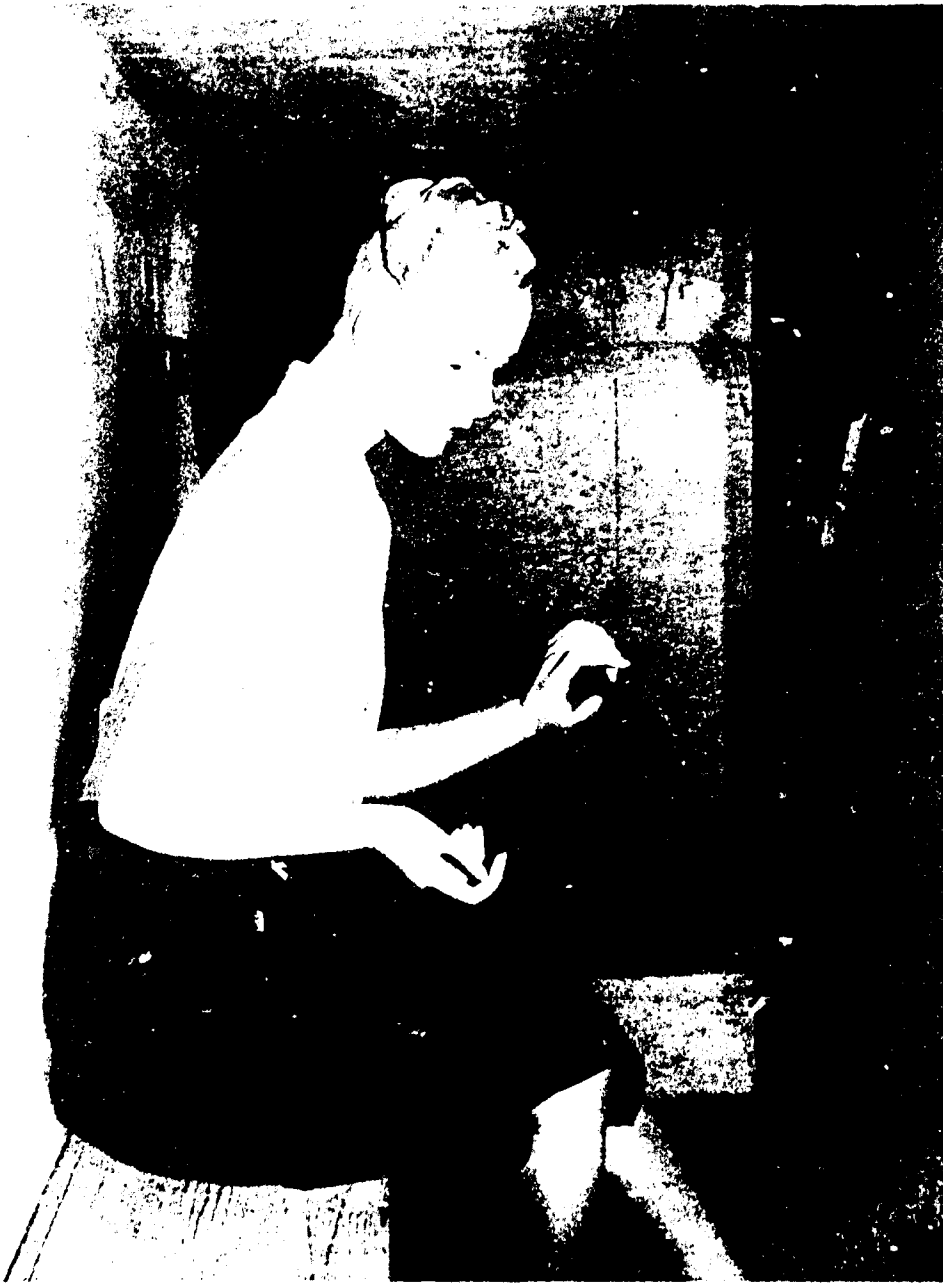
(a) *Reinforced Concrete Basement Exit.* For construction details of this shelter see Fig. A.2. Figure 2 shows the interior of the reinforced concrete basement exit at 1230 ft from Ground Zero. Sand weighing 28 lb was poured into the lower hollow half of the mannequin through an opening in the back at approximately waist level. Total dummy weight was about 60 lb. A child mannequin, weighing 7 lb, is not visible in the photograph. Gamma-radiation badges, nylon swatches, and paraffin cubes are shown in the background.

Fig. 2—Reinforced concrete basement exit before blast.

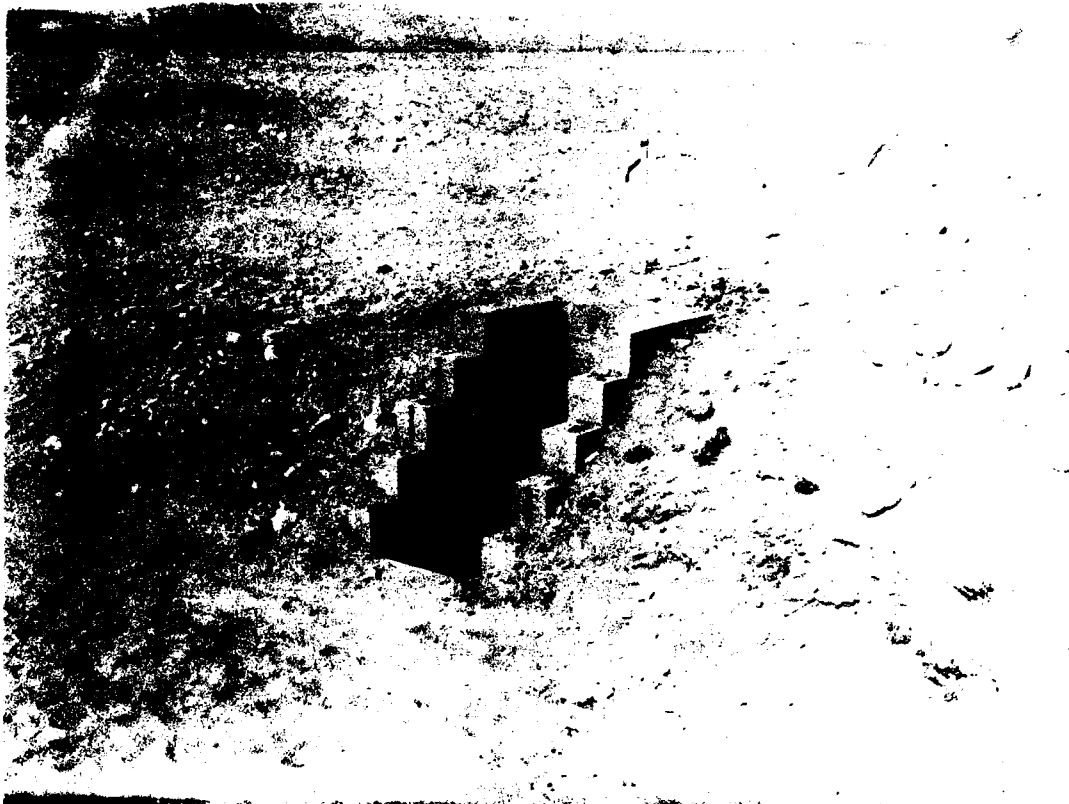
(f) *Block-wall Basement Exit at 1800 Ft from Ground Zero.* See Fig. A.6 for plan. Figure 10 is a view of the entrance to the block-wall basement exit before the blast. Figure 11 shows the minor damage done to the exterior of this shelter by the blast. There was no interior damage. The roof slab showed no evidence of any cracking.

Fig. 10—Entrance to block-wall basement exit before blast.

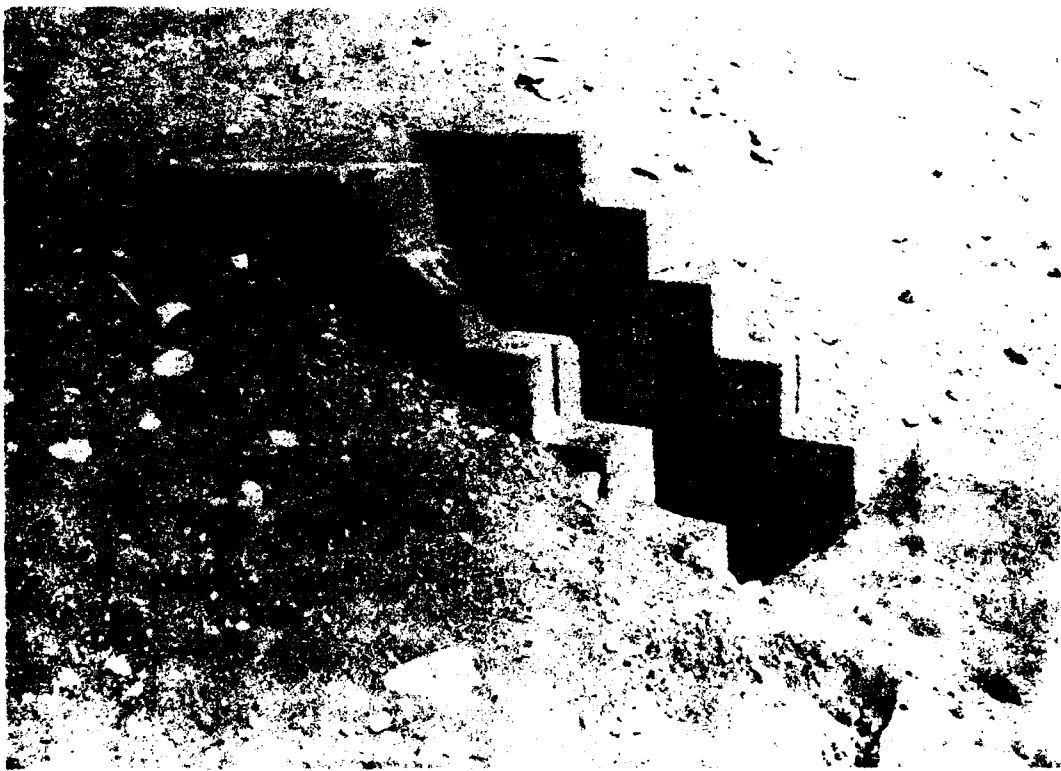
Fig. 11—Entrance to block-wall basement exit after blast.

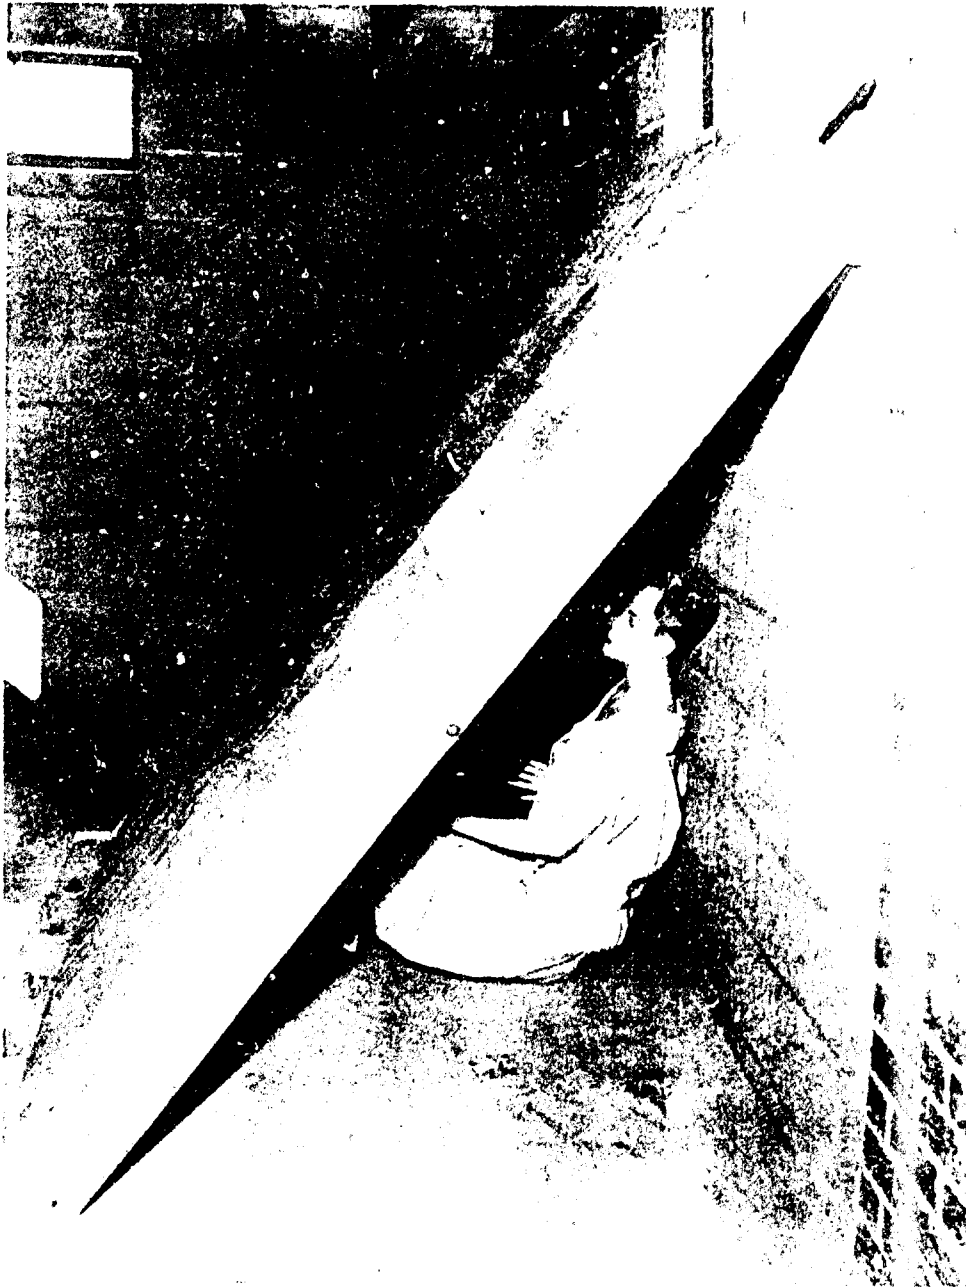
(i) *Wooden Lean-to Shelter at 3500 and 7500 Ft from Ground Zero.* See Fig. A.8 for the construction drawing. This shelter was built 6 ft 0 in. long instead of the 8 ft 0 in. shown. Figures 14 and 15 show the wooden lean-to in the basement of the house at 3500 ft before and after the blast. The mannequin in the shelter was removed after the explosion and before the photograph was taken.

Fig. 14—Lean-to at 3500 ft before blast.

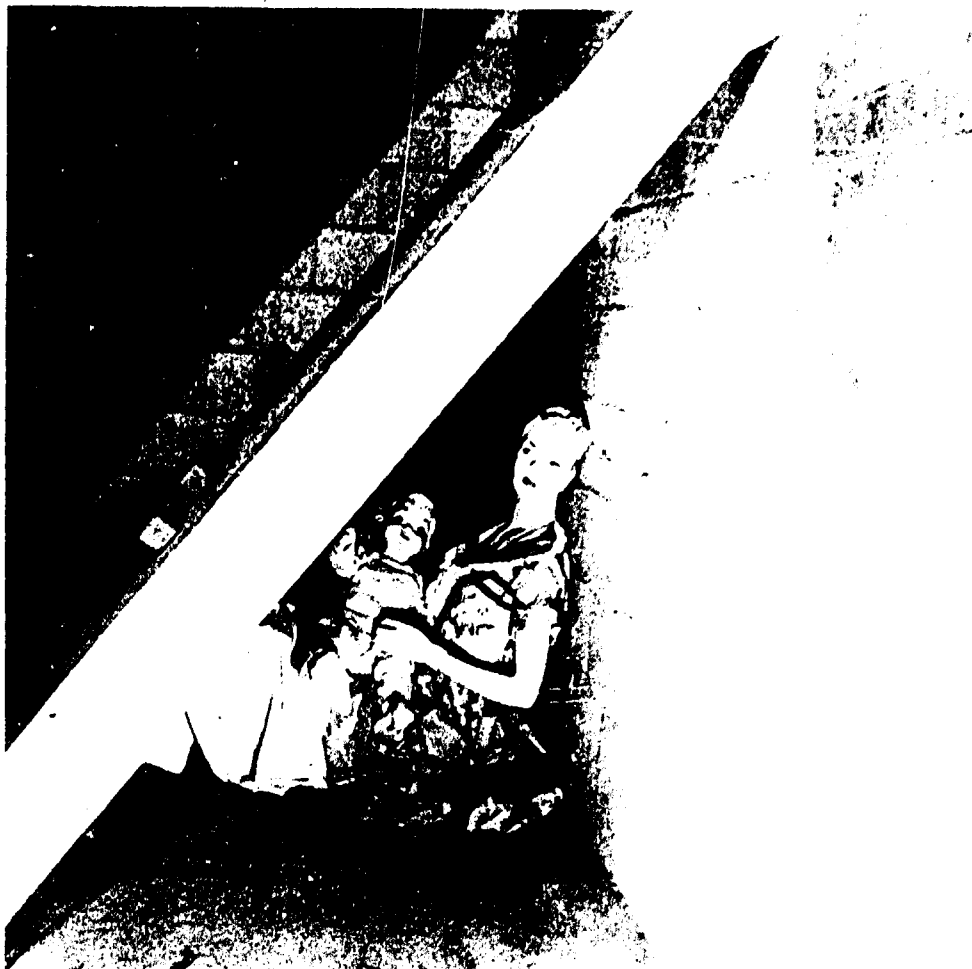
Figure 16 shows the wooden lean-to shelter in the basement of the house at 7500 ft before the blast. The clothed female dummies weighed 30 lb each, and the child weighed 7 lb. All mannequins were undamaged and remained in their original positions.

Fig. 16—Lean-to at 7500 ft before blast.

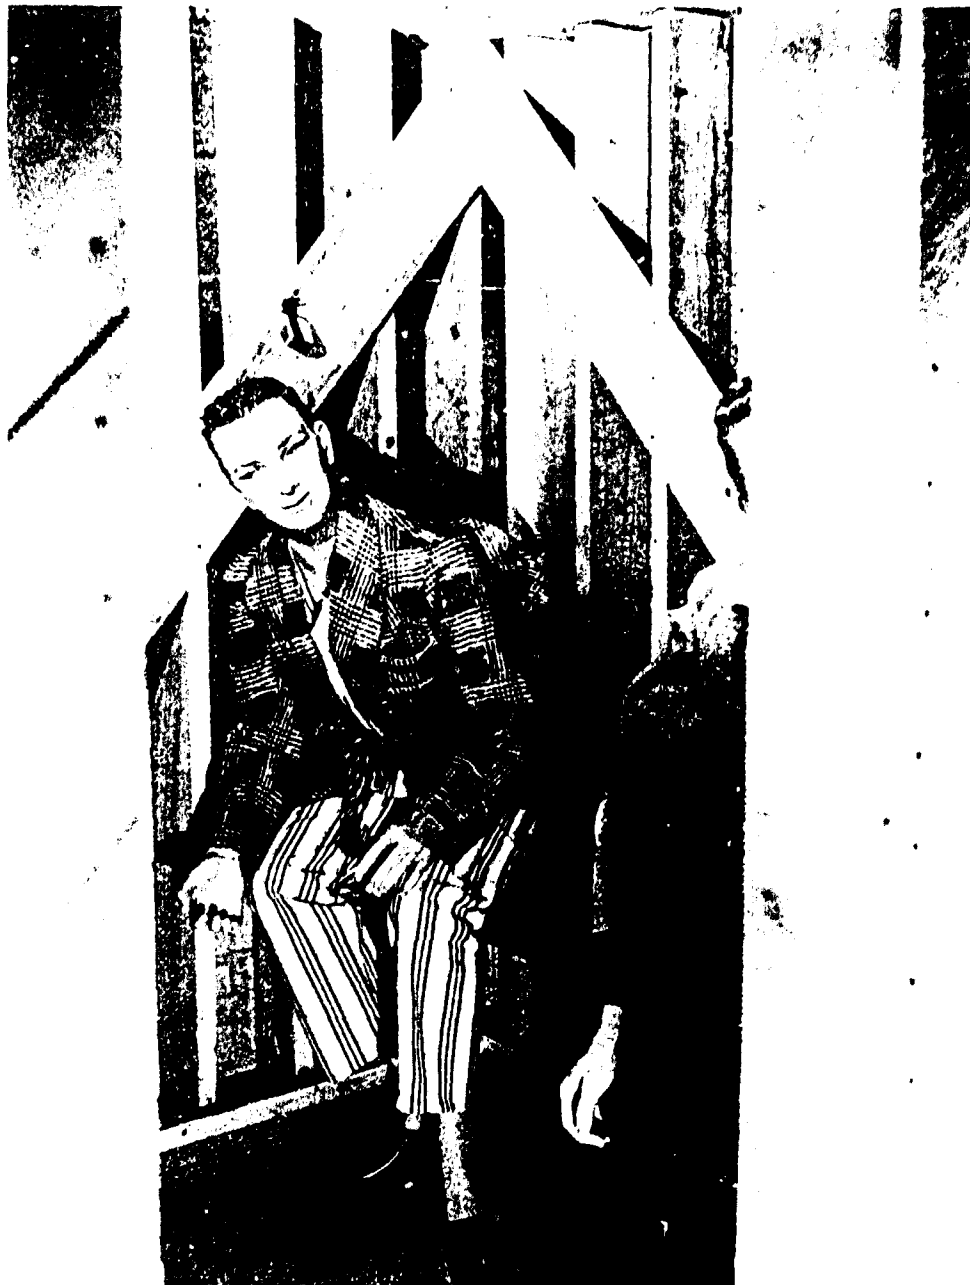
(j) *Basement Corner Room Shelter at 3500 and 7500 Ft from Ground Zero.* For drawing of this shelter see Fig. A.9. Figure 17 is a view of the interior of this shelter in the house at 3500 ft before the blast. Figures 18 and 19 show the interior of this shelter at 7500 ft before and after the blast. Male mannequins weighed 35 lb; females, 30 lb; and the child, 7 lb. None of these mannequins were damaged or moved by the blast.

Fig. 17— Basement corner room at 3500 ft before blast.

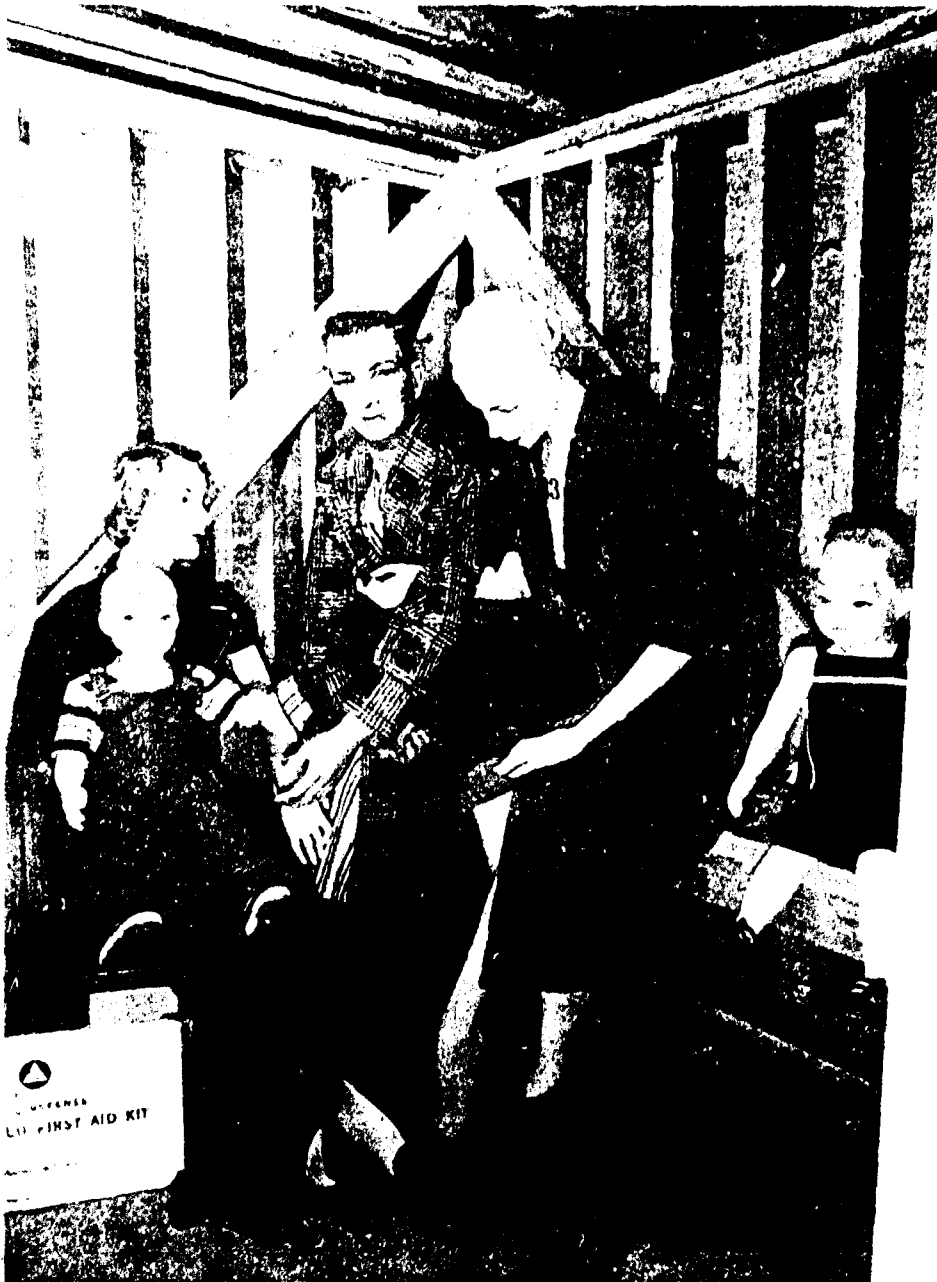
Fig. 18—Basement corner room at 7500 ft before blast.

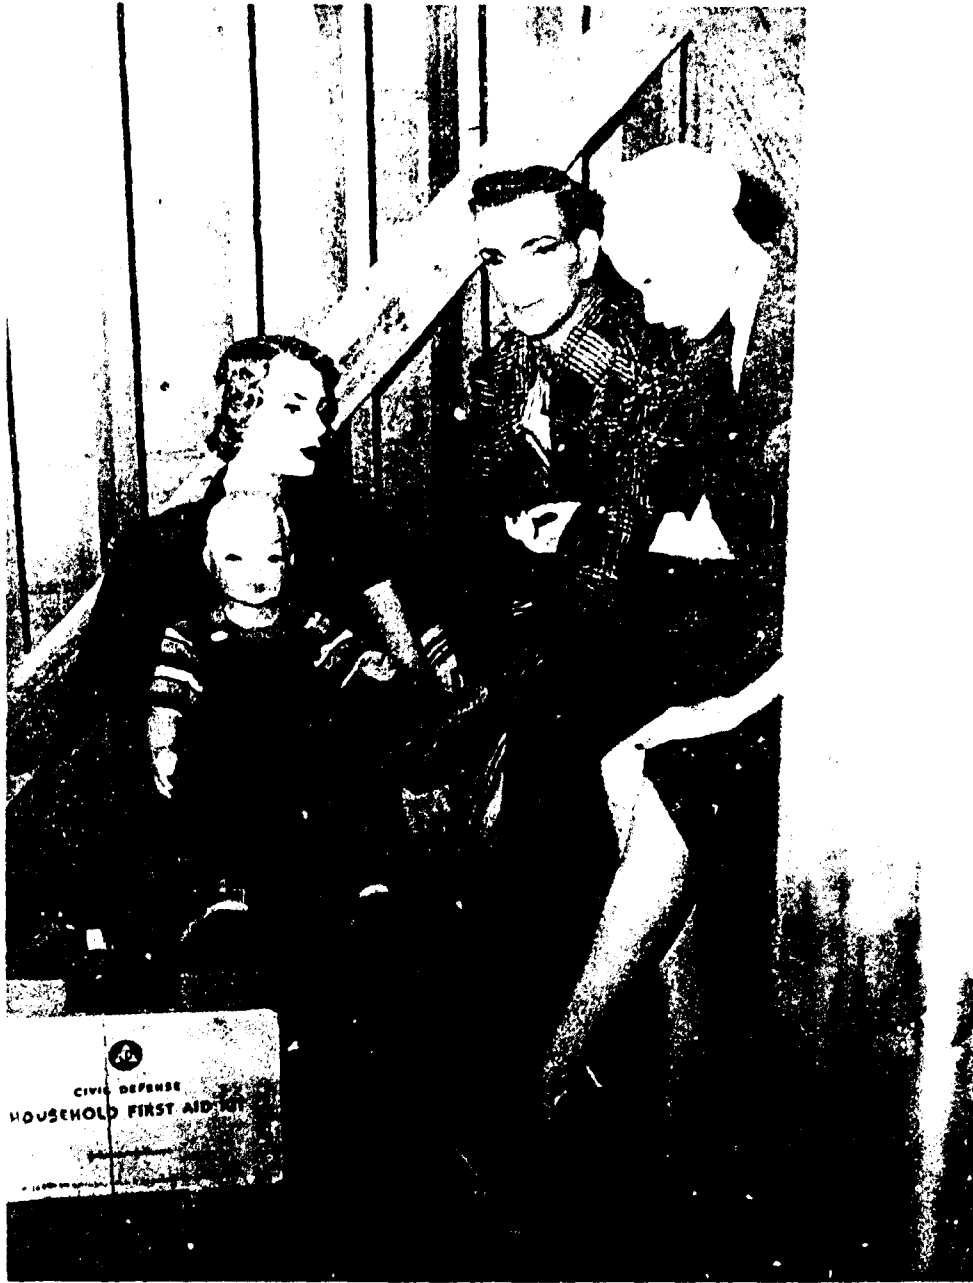
Fig. 19—Basement corner room at 7500 ft after blast.

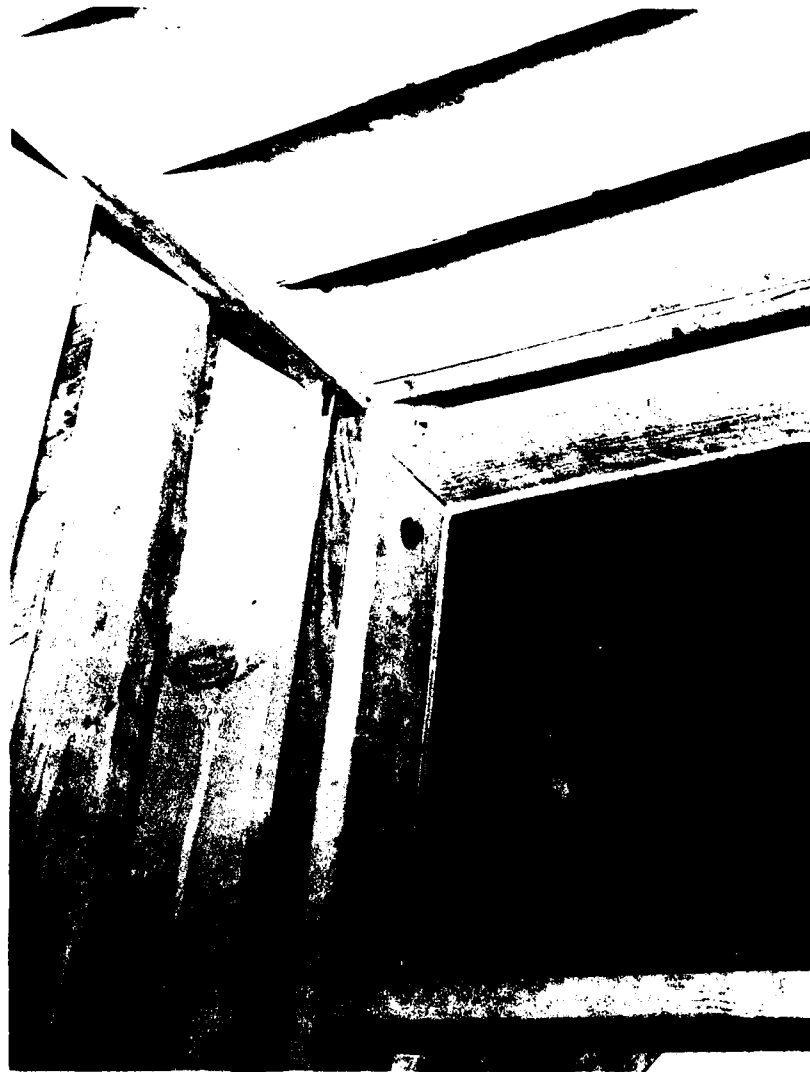
Figure 20 illustrates the minor damage in the basement corner room at 3500 ft after the blast. Only one roof joist cracked under the debris load of the collapsed house above.

Fig. 20—Damage to basement corner room at 3500 ft.

The debris load on the basement shelters at 3500 ft was small; so these shelters were not tested to their maximum capacity, such as might be experienced in the collapse of a masonry house.

Both types of indoor shelters should be tested under the debris load of a masonry house. All future tests of shelters should include instrumentation to measure interior temperatures and blast pressures.
